# The suitability of the Intake of North Bahri - El Tamaniat Pumping site (NBTPS)

**Hydraulics Research Center (HRC)**

**2nd Annual Scientific Seminar**

***Khartoum - 18th Dec. 2016***

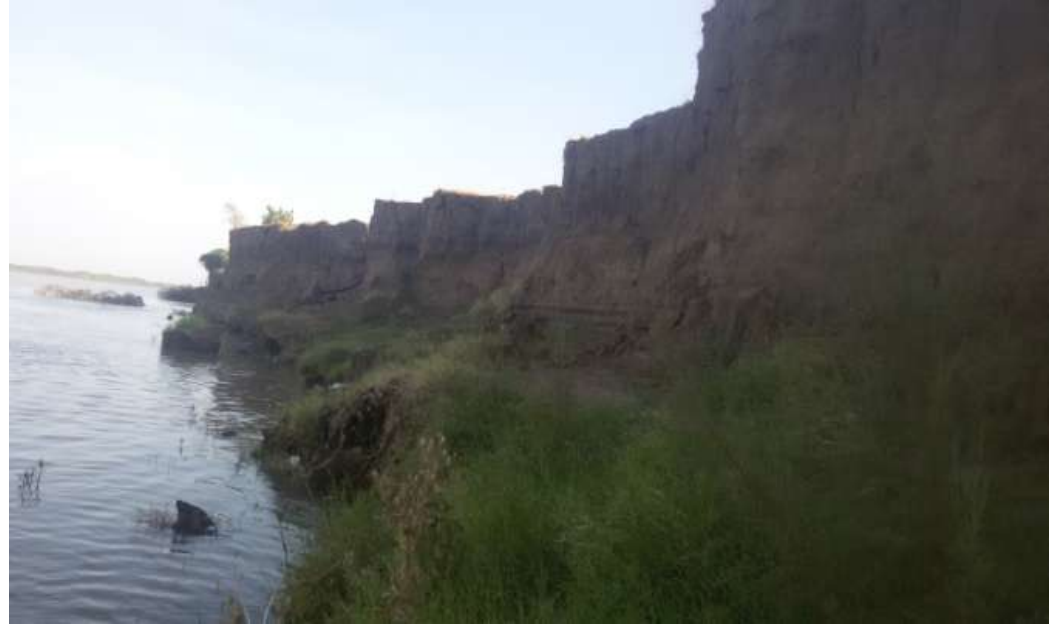
**1/ Heavy erosion on the left bank of the island in front of the Station.**

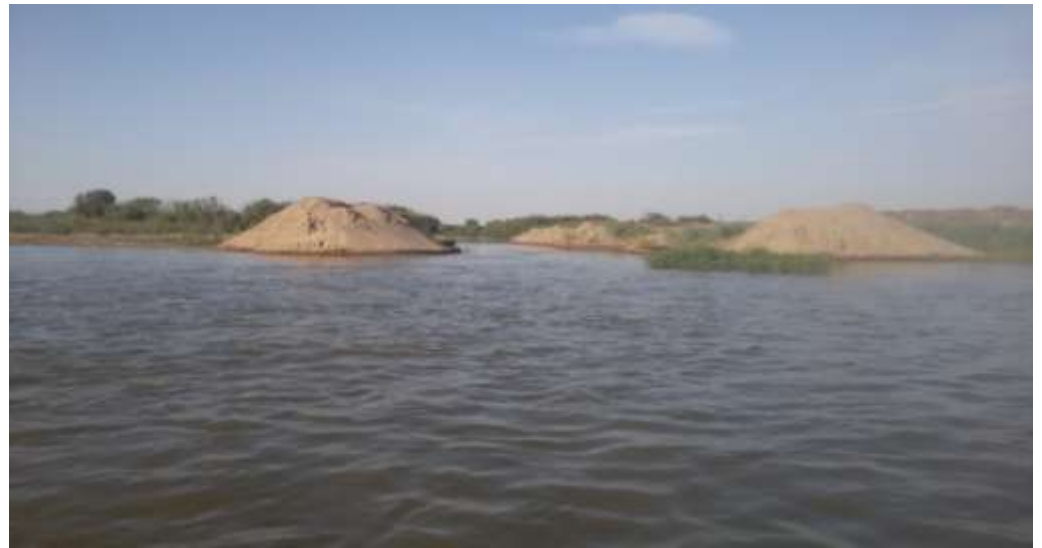
**2/ heaps of dredged sand at the inlet of the right branch.**

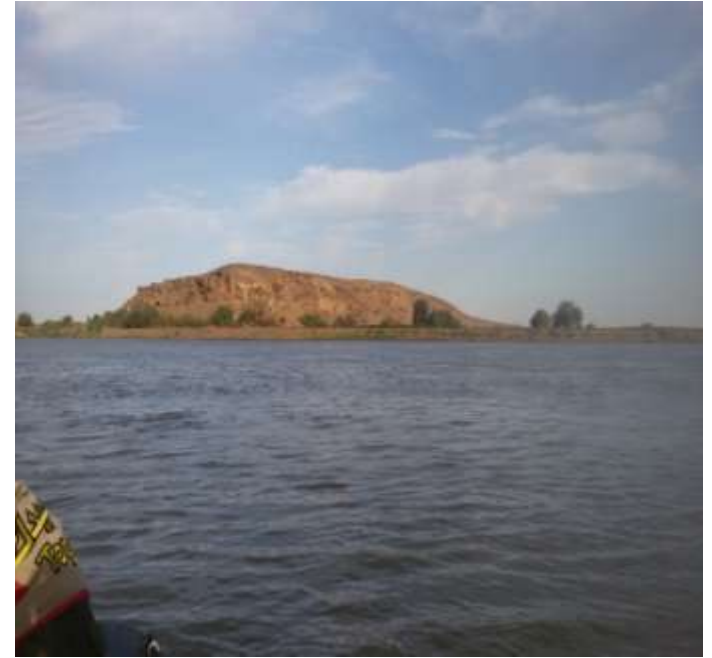
**1/ A mountain on the Left Bank furthers downstream the Station**

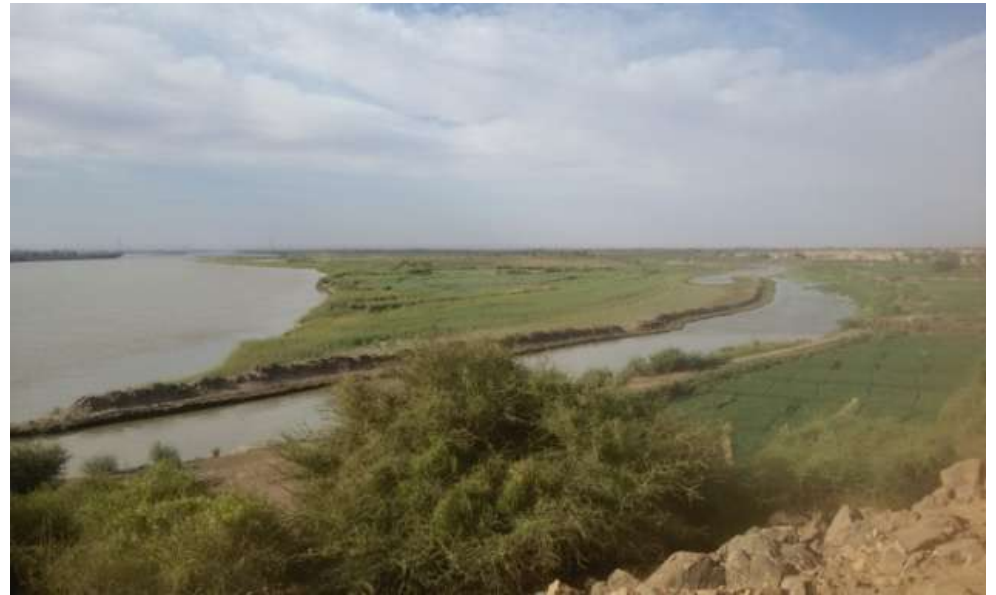
**2/ stiff clay and rocks opposite to the pumping station**

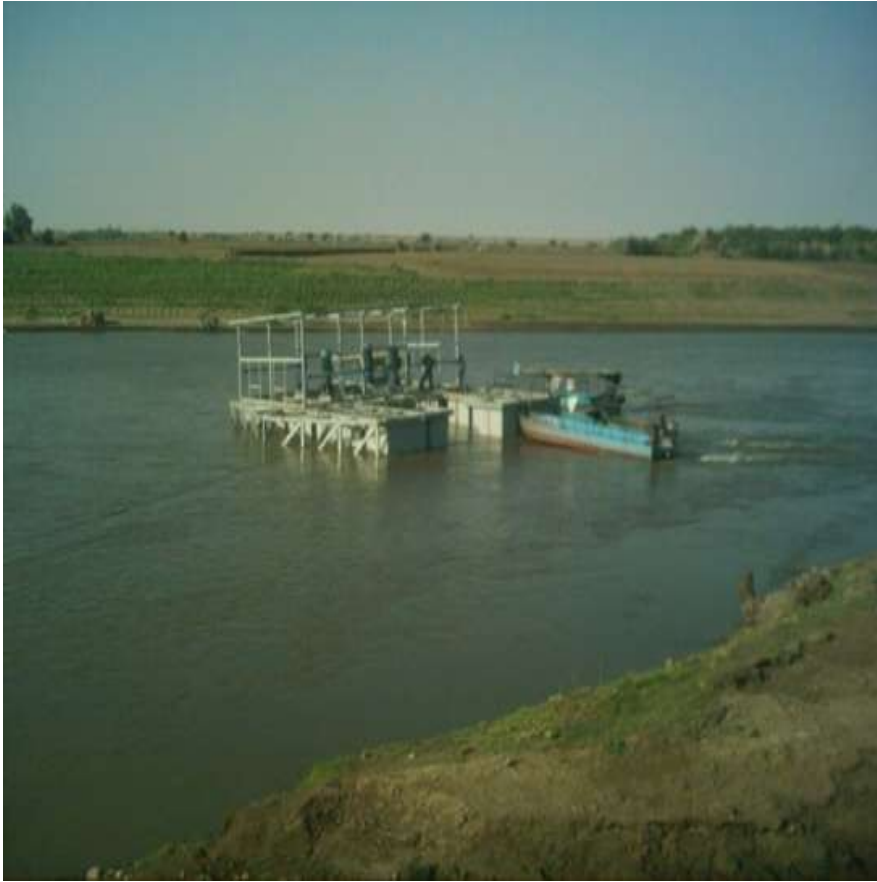
**Pumping site location (2009)**

# Observations and main results (4): changes in right branch

- The right branch is decreasing (34 m/year).
- Minimum bed level of the right branch is about 6 m above that of the main channel;
- the 50 years return minimum water level is lower than the minimum bed level of the right branch;
- The GERD will increase the minimum water level by about 0.5 m.
- Earlier the branch under study was the main river. (official reports and personal communications).

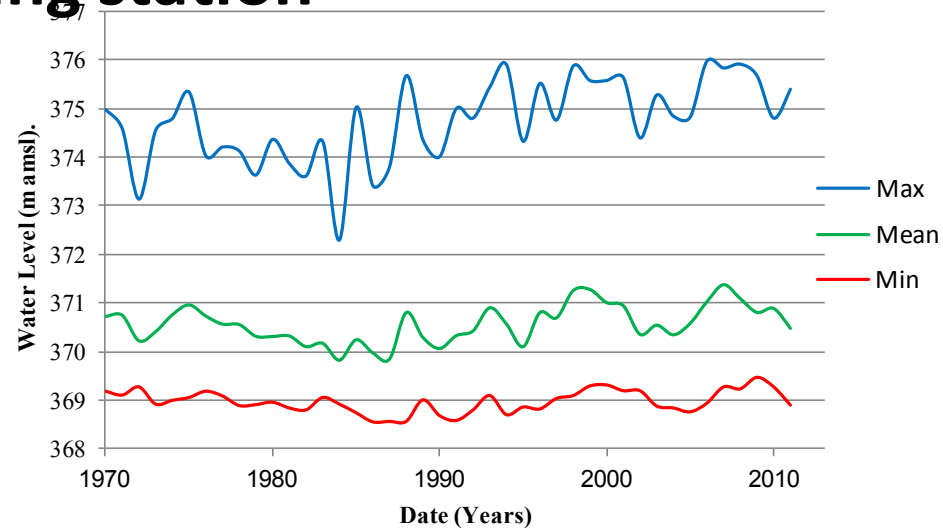
water levels at Tamaniat gauging station (3 Km d/s the NBTPS)

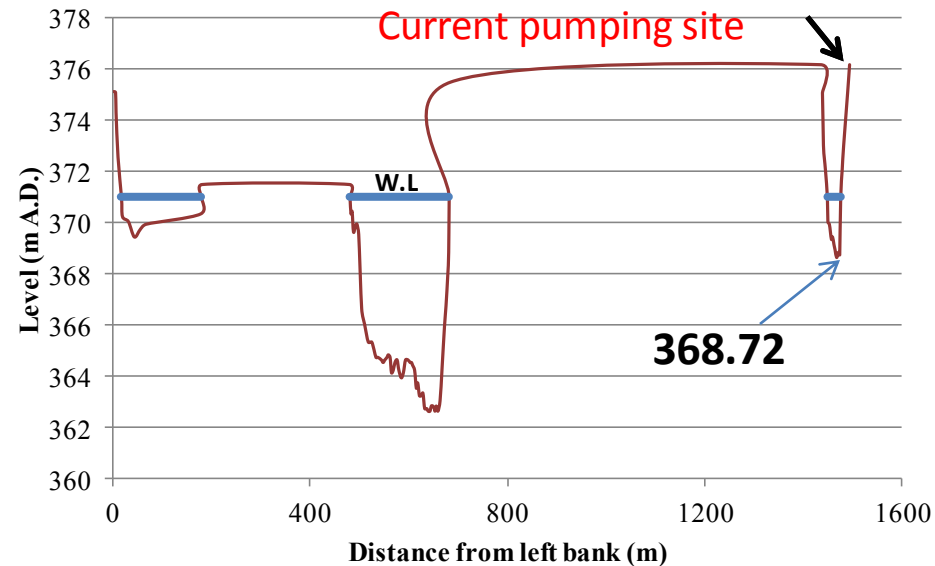
Cross section at the center line of the NBTPS
